Tesla Motors Model S battery had thermal runaway

What really caused the fiery October 1, 2013 incident?

Tesla's theory: event caused by metallic debris on road impaling battery

Theory has some issues: could it instead have been an internal field-failure?

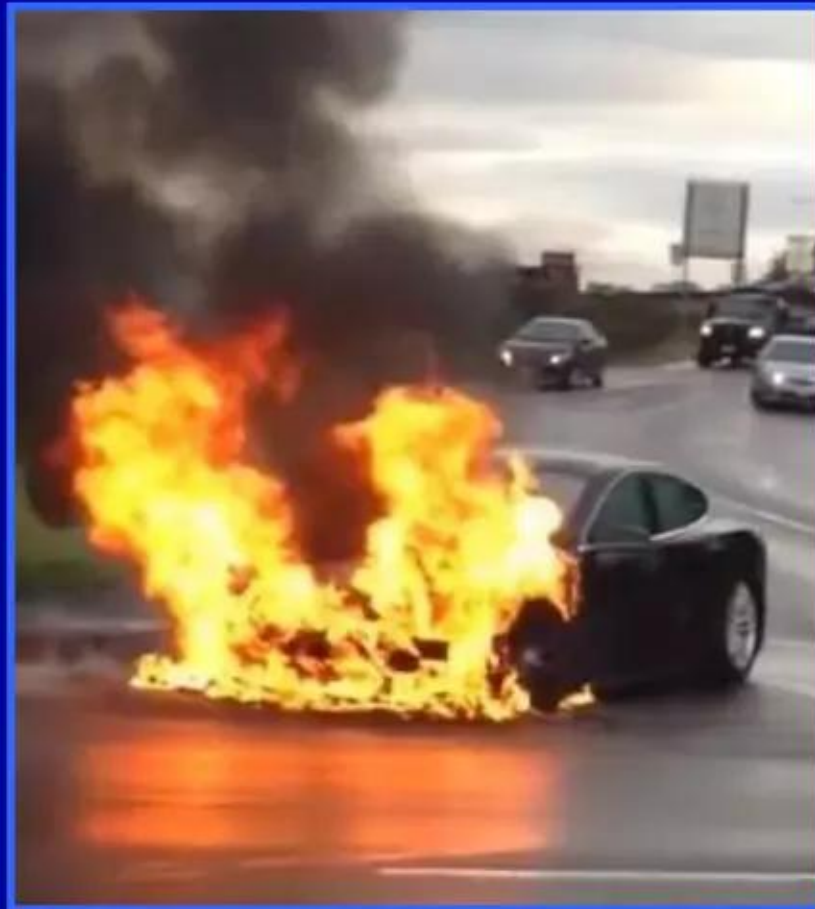
October 1, 2013 - Kent, WA USA
Scene before arrival of firefighters

Tesla Motors Model S in flames

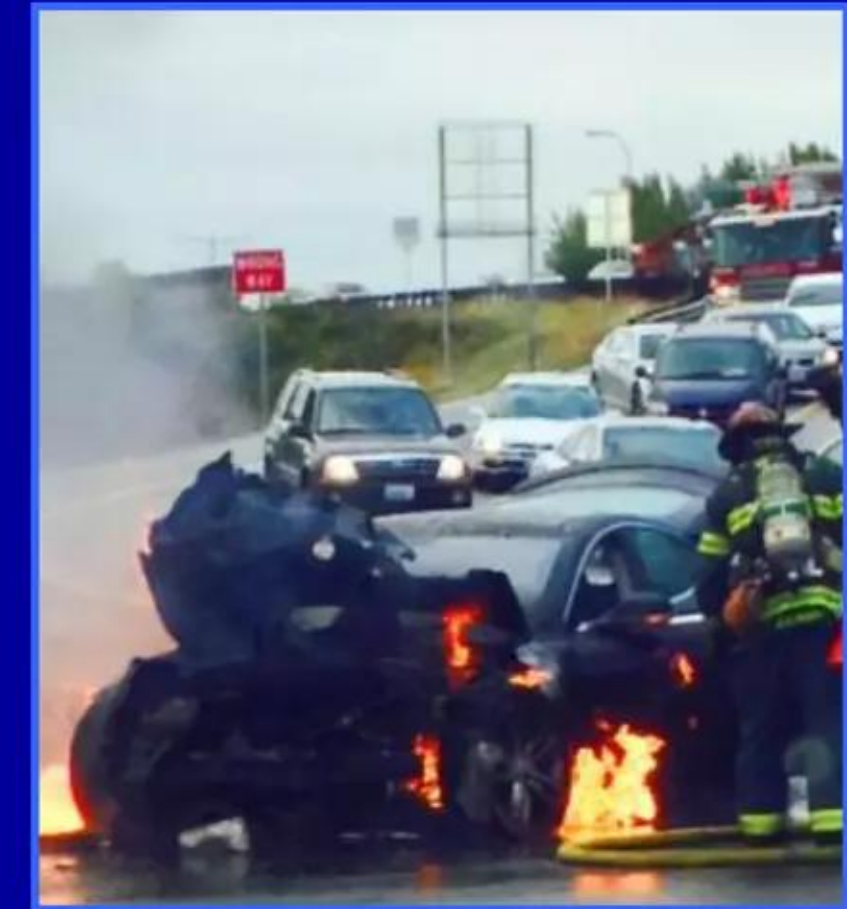
October 1, 2013 - Kent, WA USA
Scene after arrival of firefighters

Fire now partially extinguished

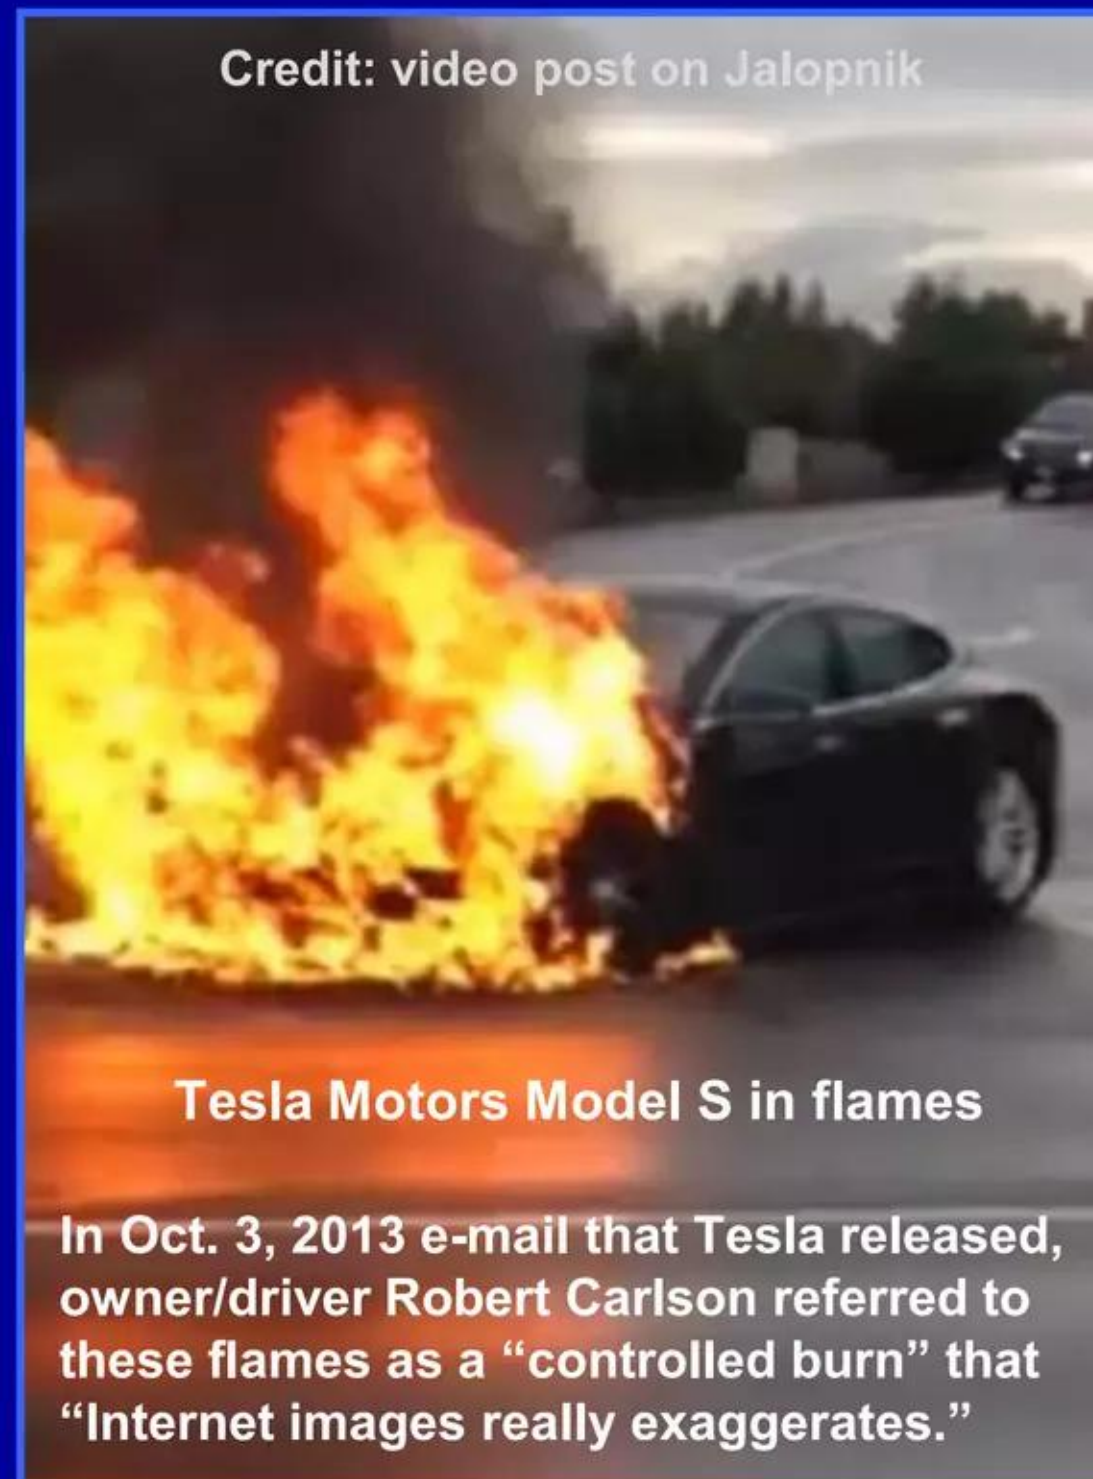
October 1, 2013 - Kent, WA USA
Scene just as firefighters arrived

**If this mini-inferno is truly
“controlled” then we are astounded.**

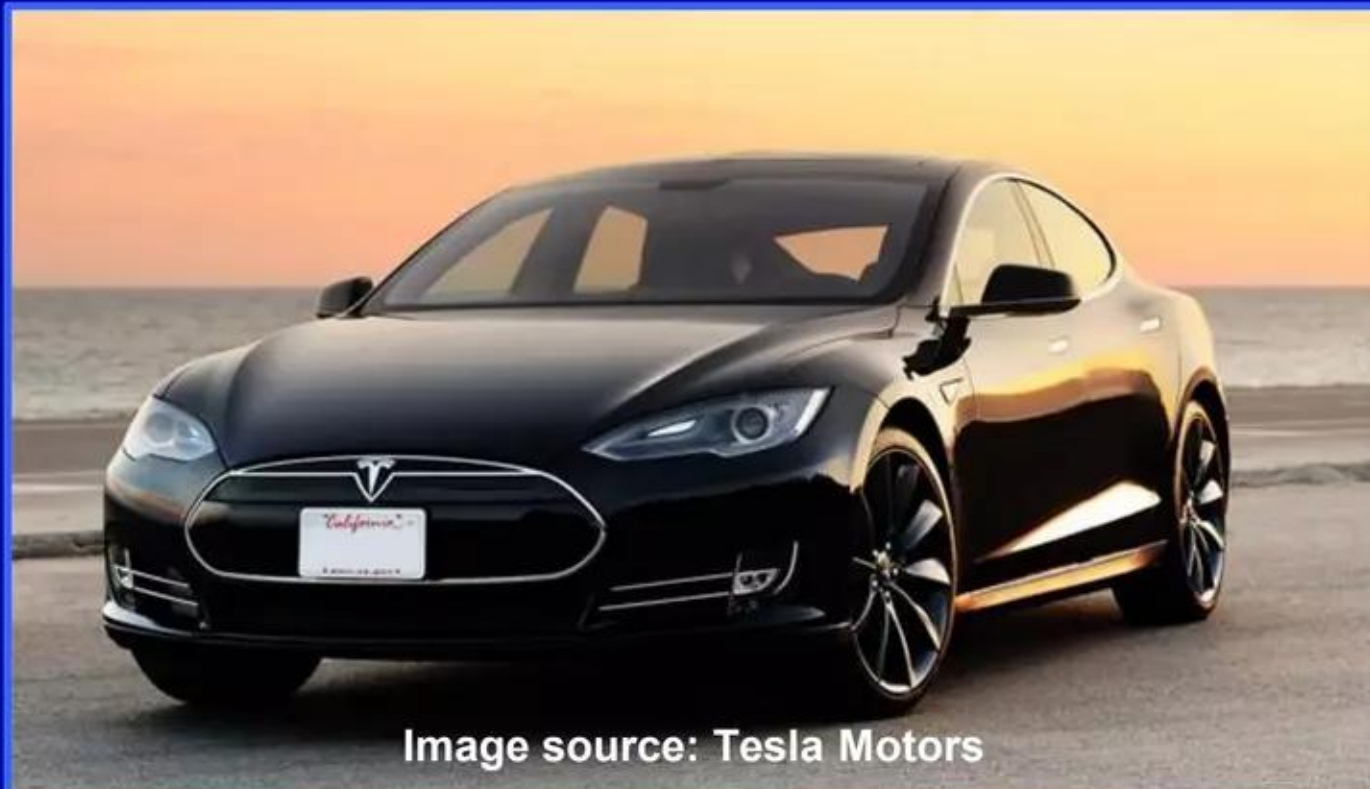
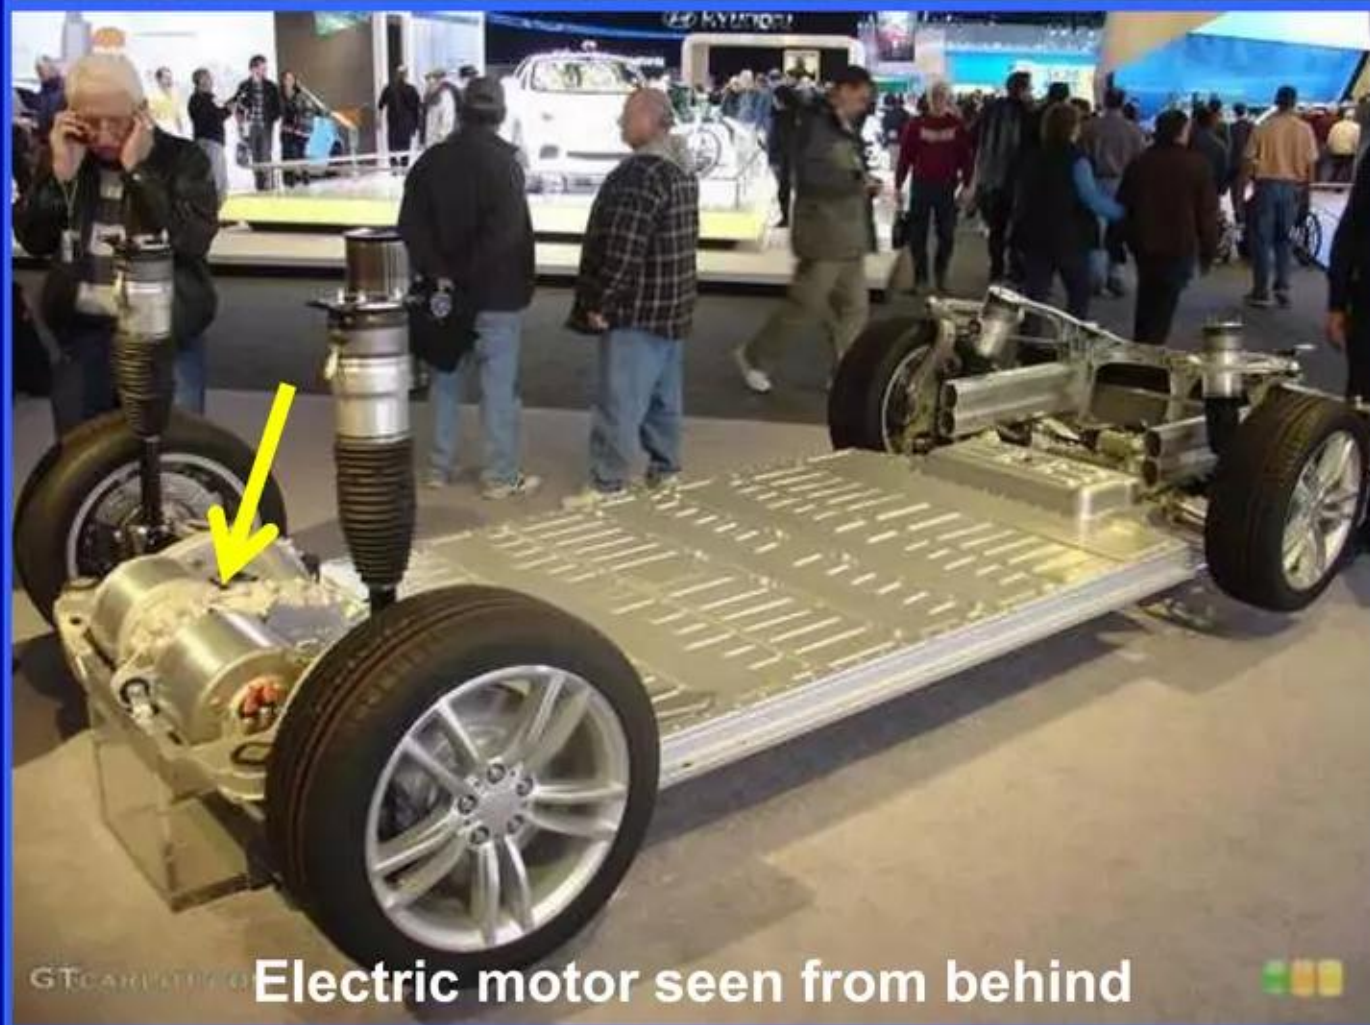
Basic functional organization of key system components

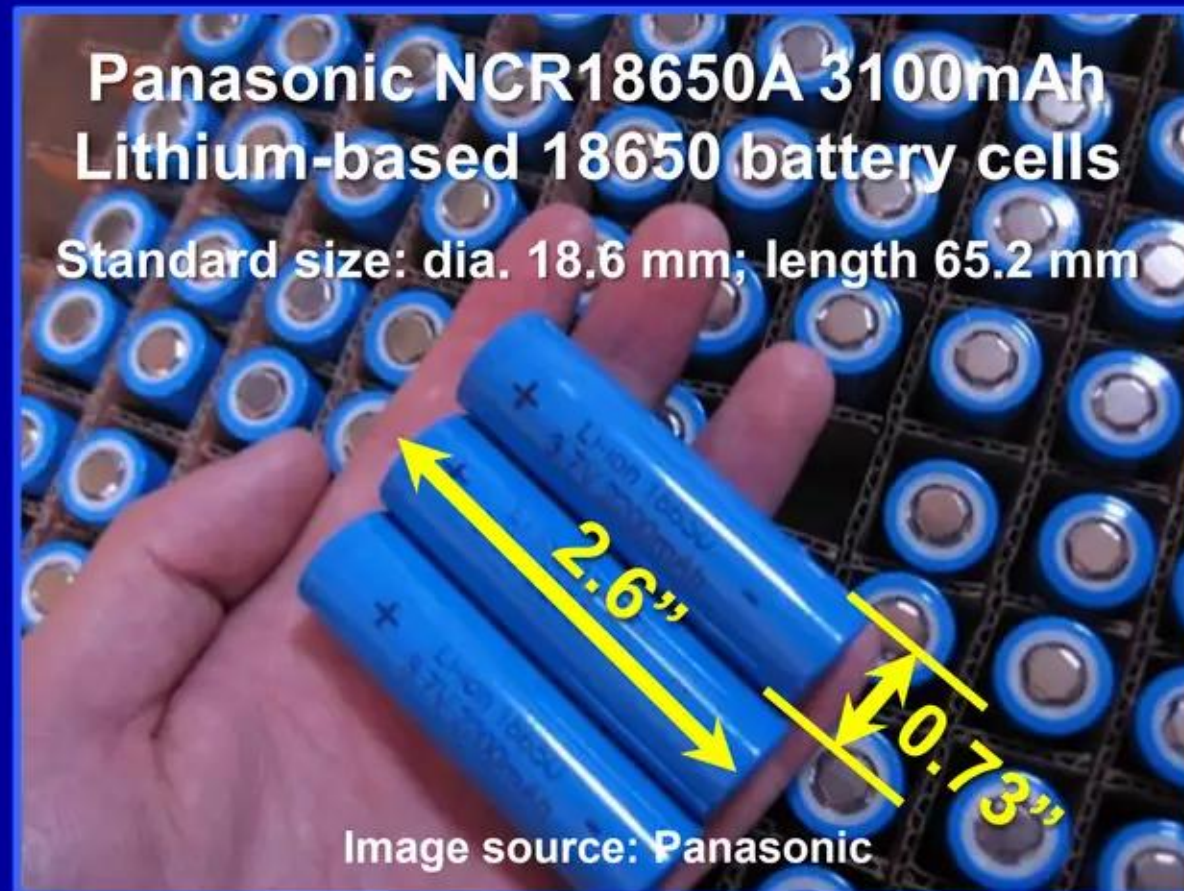
Battery pack integrates/controls up to ~7,000 Panasonic Li-based cells

Model S battery pack uses 18650As with NCA chemistry; that is, a Lithium nickel cobalt aluminum (NCA or chemically = LiNiCoAlO_2) cathode chemistry developed by Panasonic. The ~7,000 such batteries contained in a Model S pack contain specialized formulation of NCA and other unique characteristics that have been specifically optimized for EV applications (creating a so-called “automotive grade” 18650A cell). Please note this is not exactly the same as commodity 18650 battery cells that Panasonic manufactures and sells for the consumer retail market

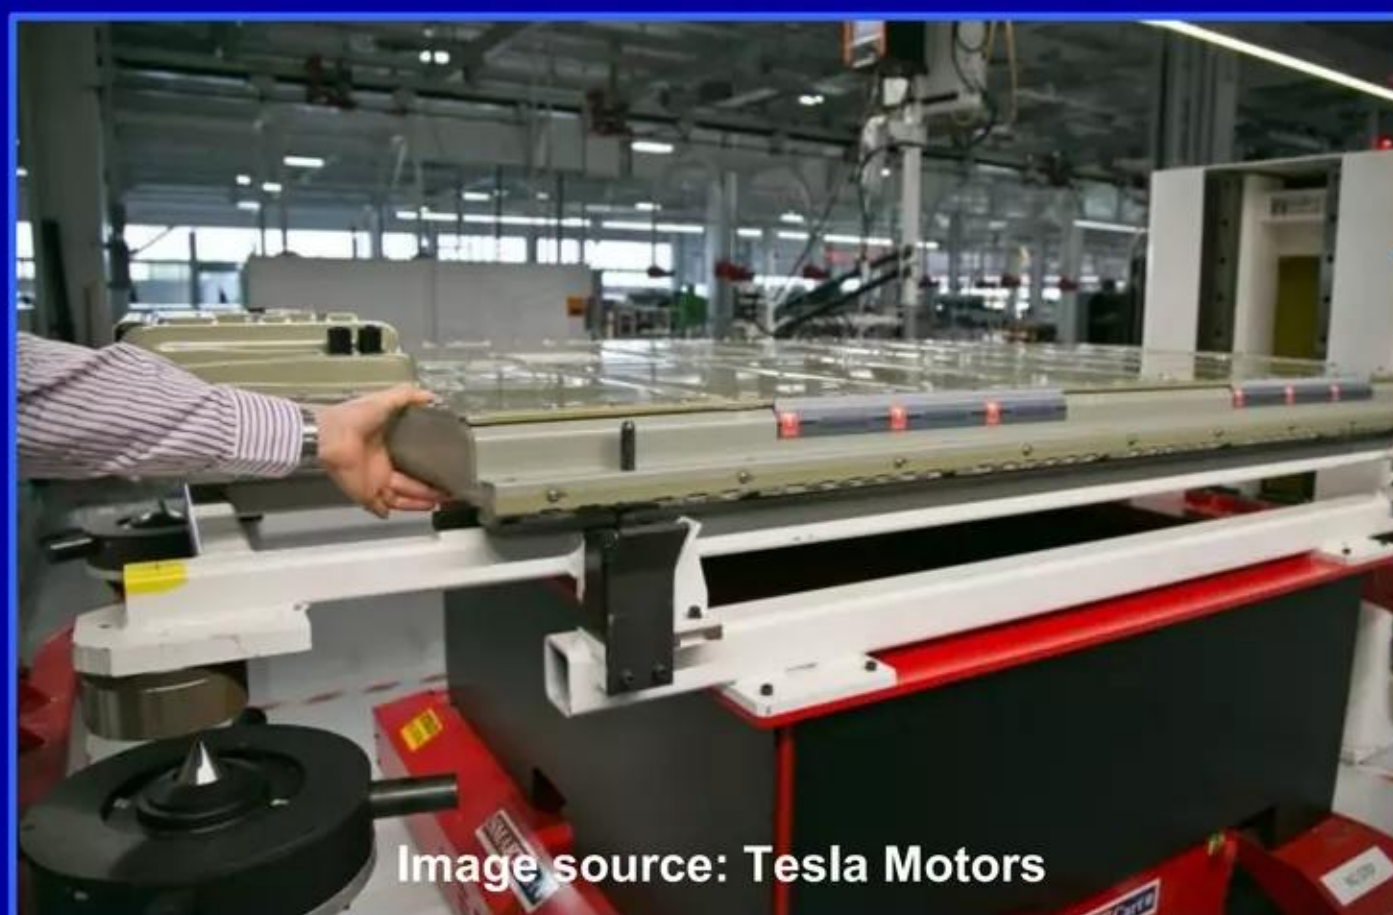
Tesla employee grasping a Model A battery pack

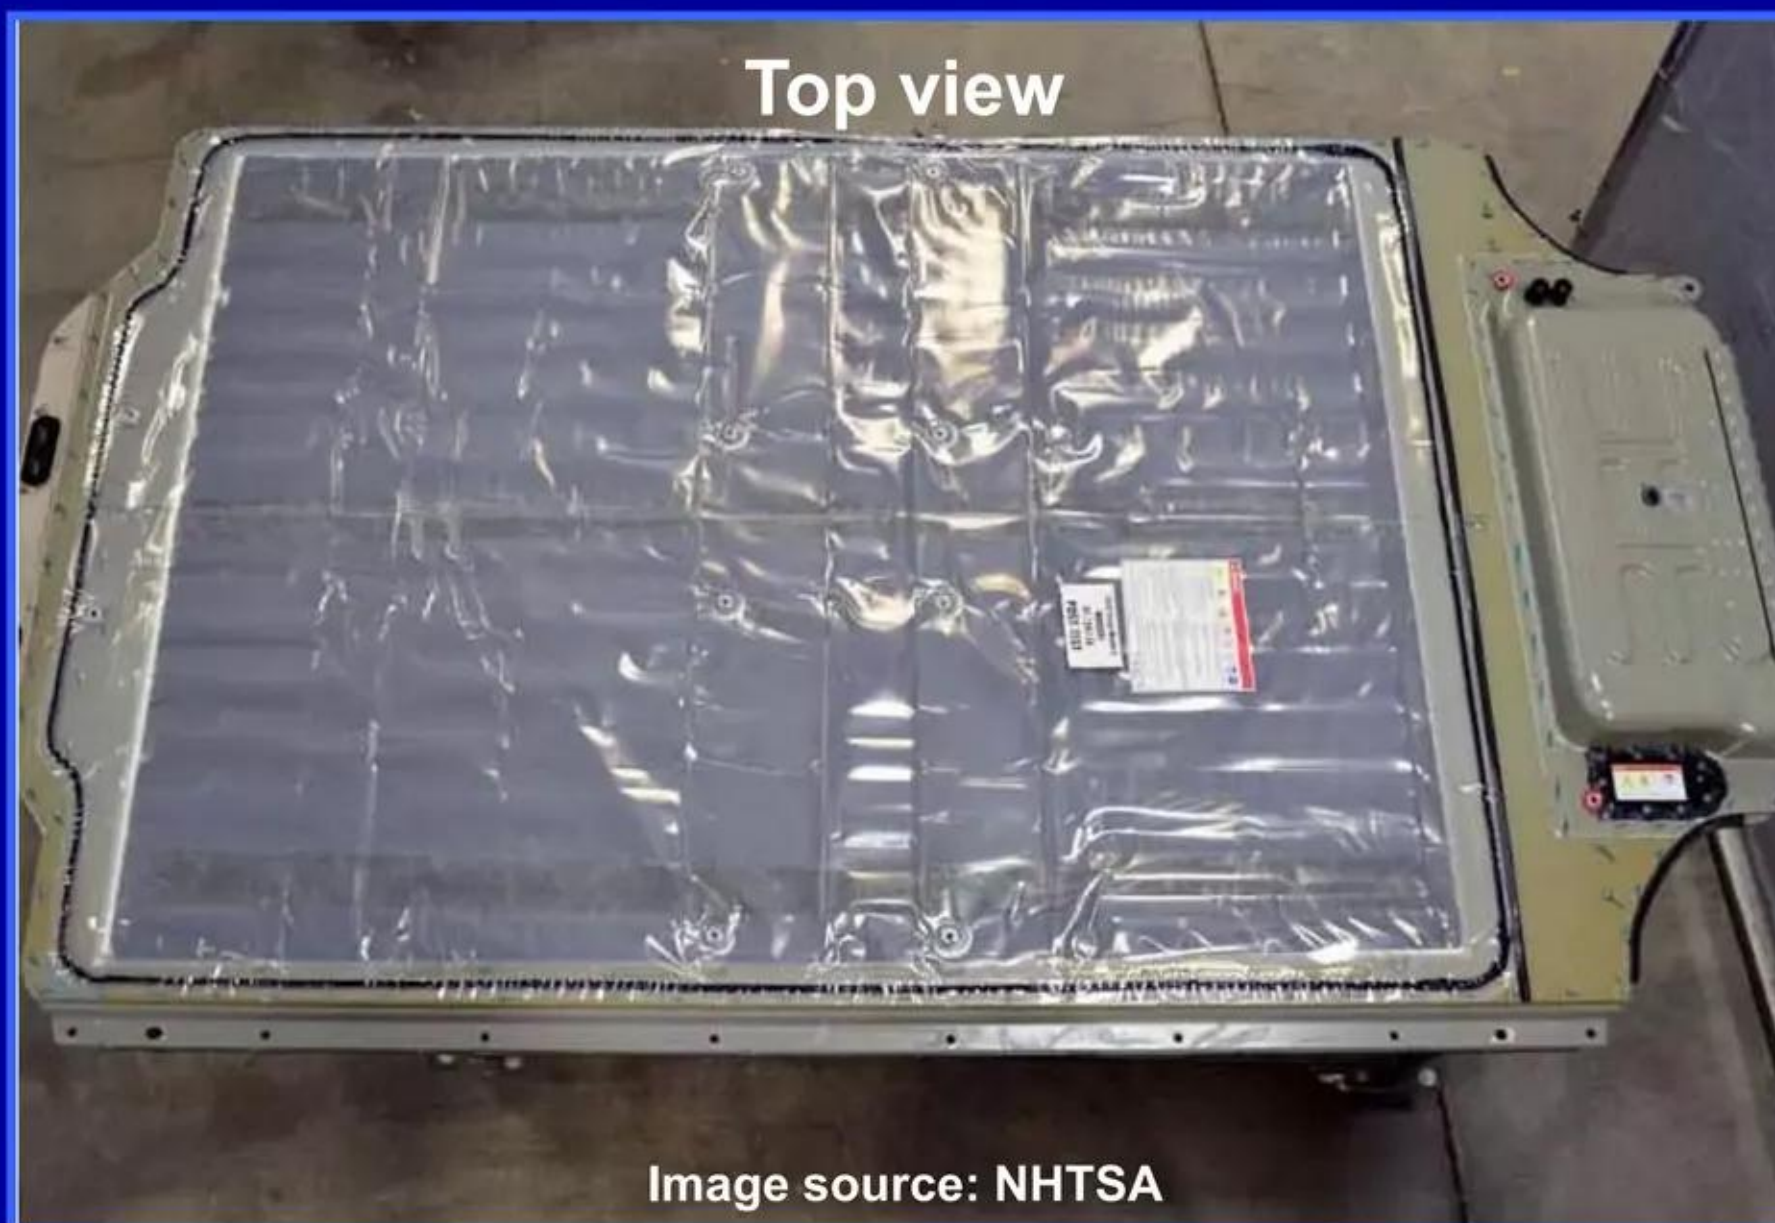
Close-packed 18650 batteries are oriented vertically within 14 individual modules

Image shows upper surface of battery pack

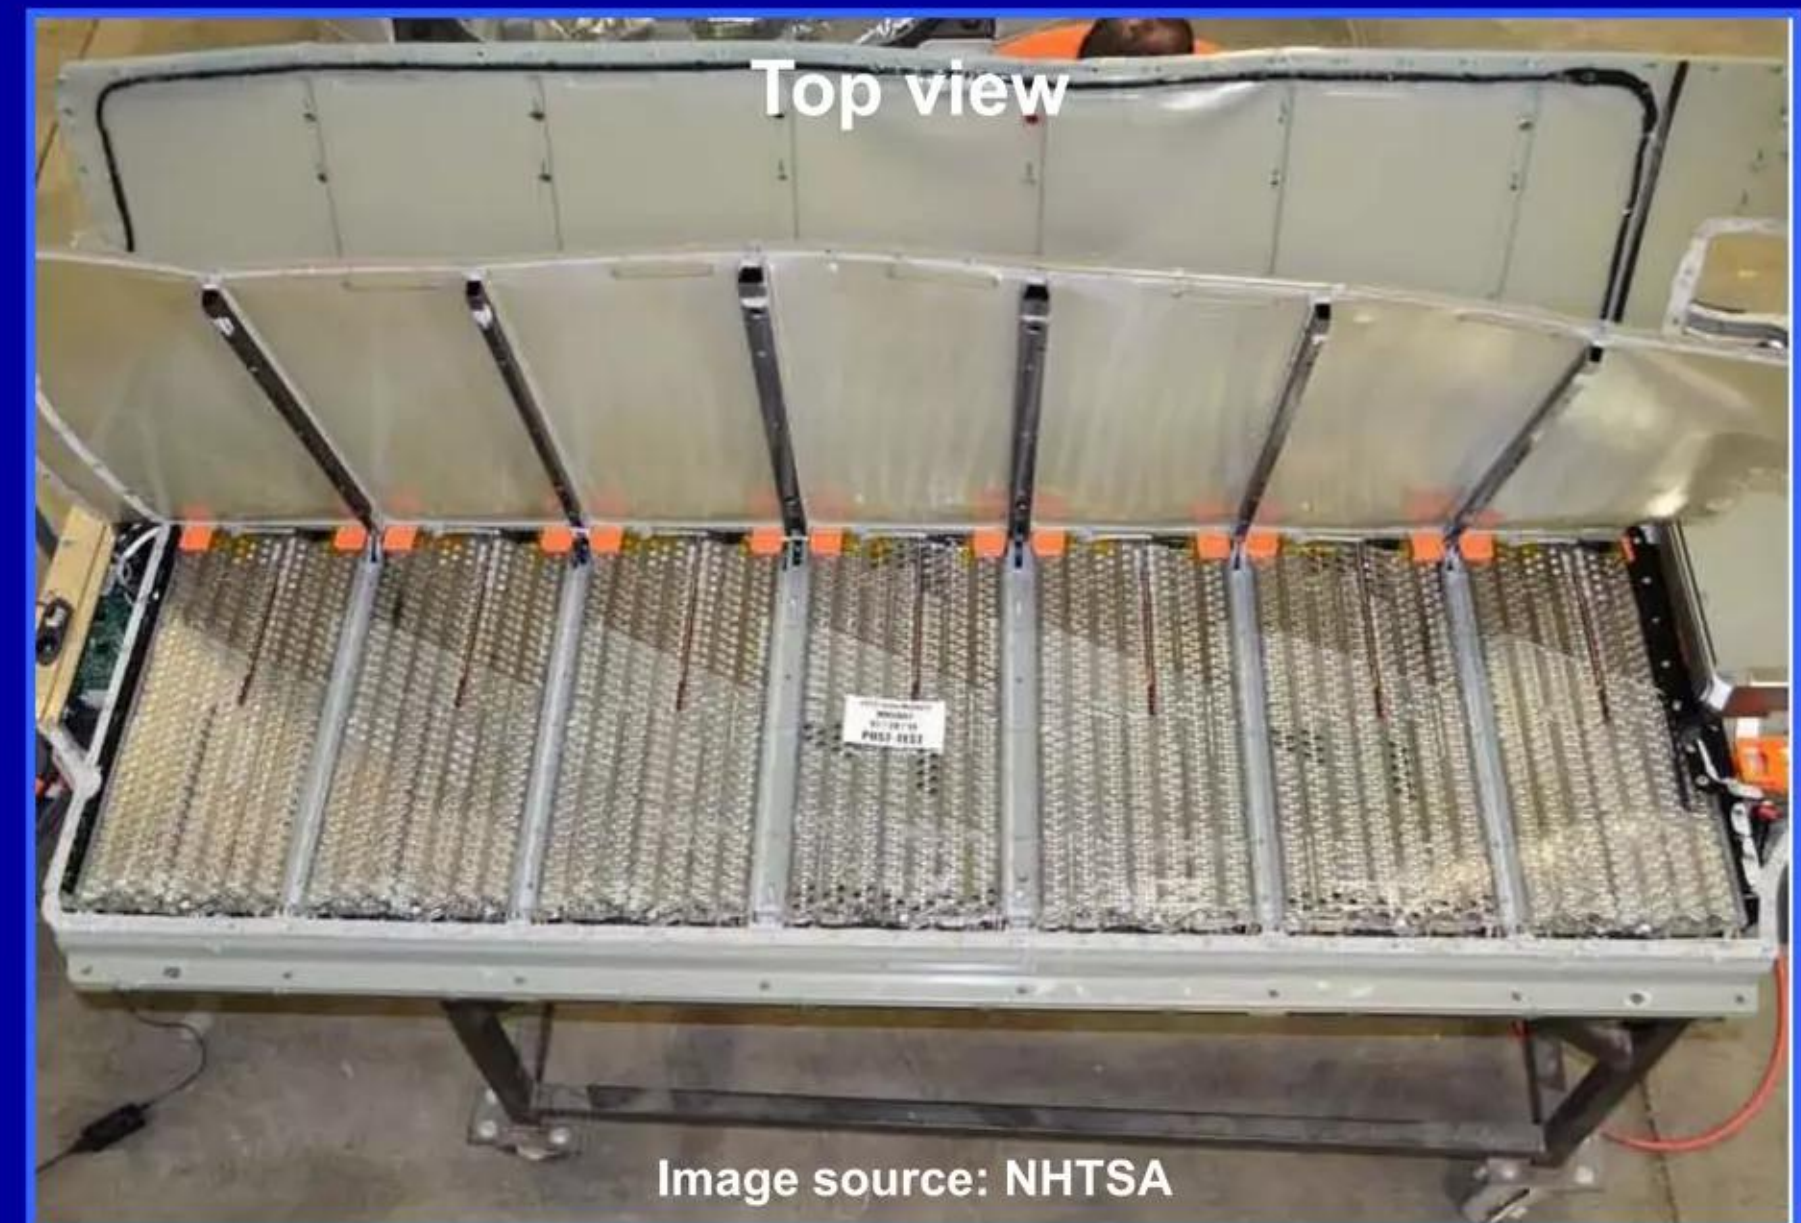
Half of battery pack now exposed: shows 7 modules

Note: 85 kWh Model S battery pack differs: has 8 modules per side for total of 16

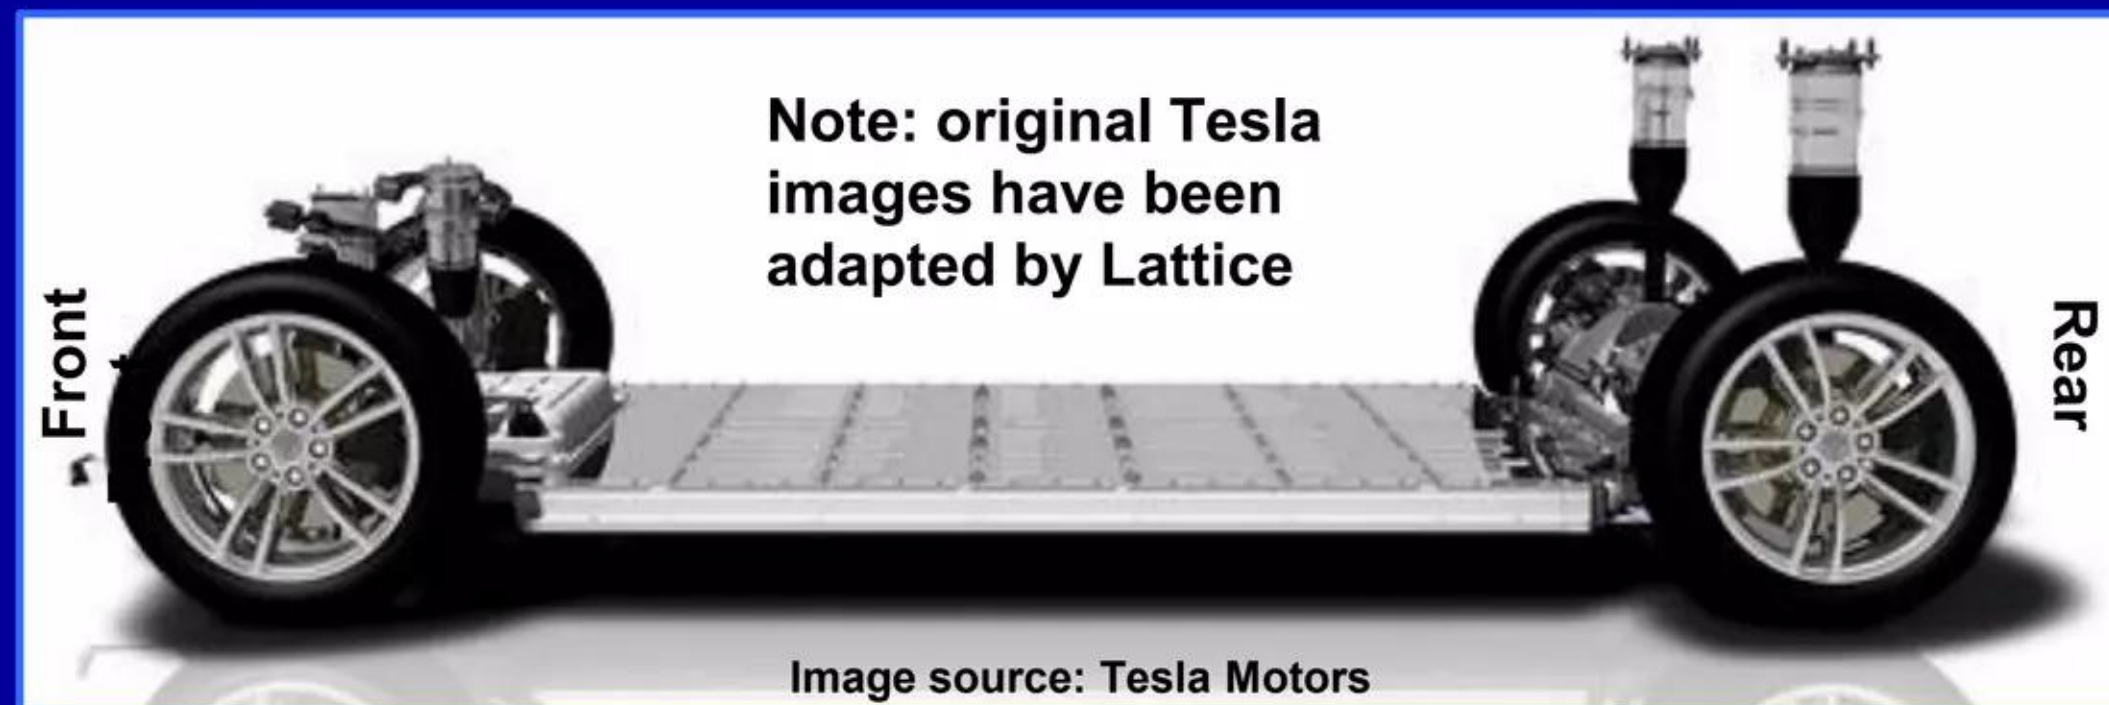
Battery pack is tightly integrated with car's major structural components

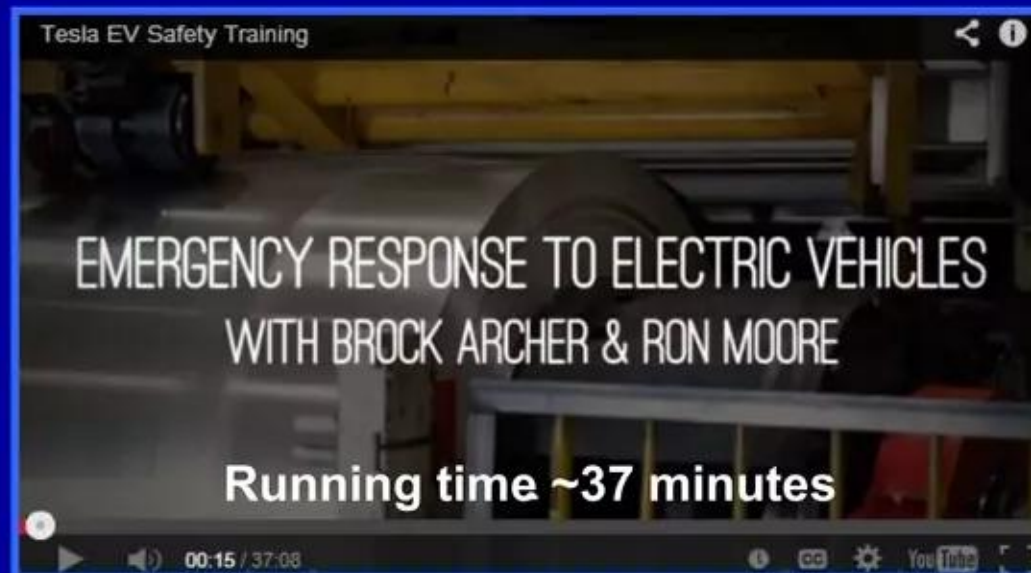
Company's safety training video shows smooth underbody of vehicle

Very smooth, turbulence-free underbody makes significant contribution to car's very low drag coefficient (Cd) of ~0.24

- ✓ Video was produced to help first responders at EV road accidents, especially the firefighters, to be aware of key issues with EV electrical systems that are not found on IC engine cars: e.g., high-voltage components and wiring; safely disconnecting the battery subsystem; locations where structural cuts can be made safely; etc.
- ✓ Note the relatively smooth surface of car's underbody
- ✓ Integrated "armor plate" protects entire battery pack from impacts originating from underneath the vehicle
- ✓ Vehicle upended here is a new Tesla Motors Model S

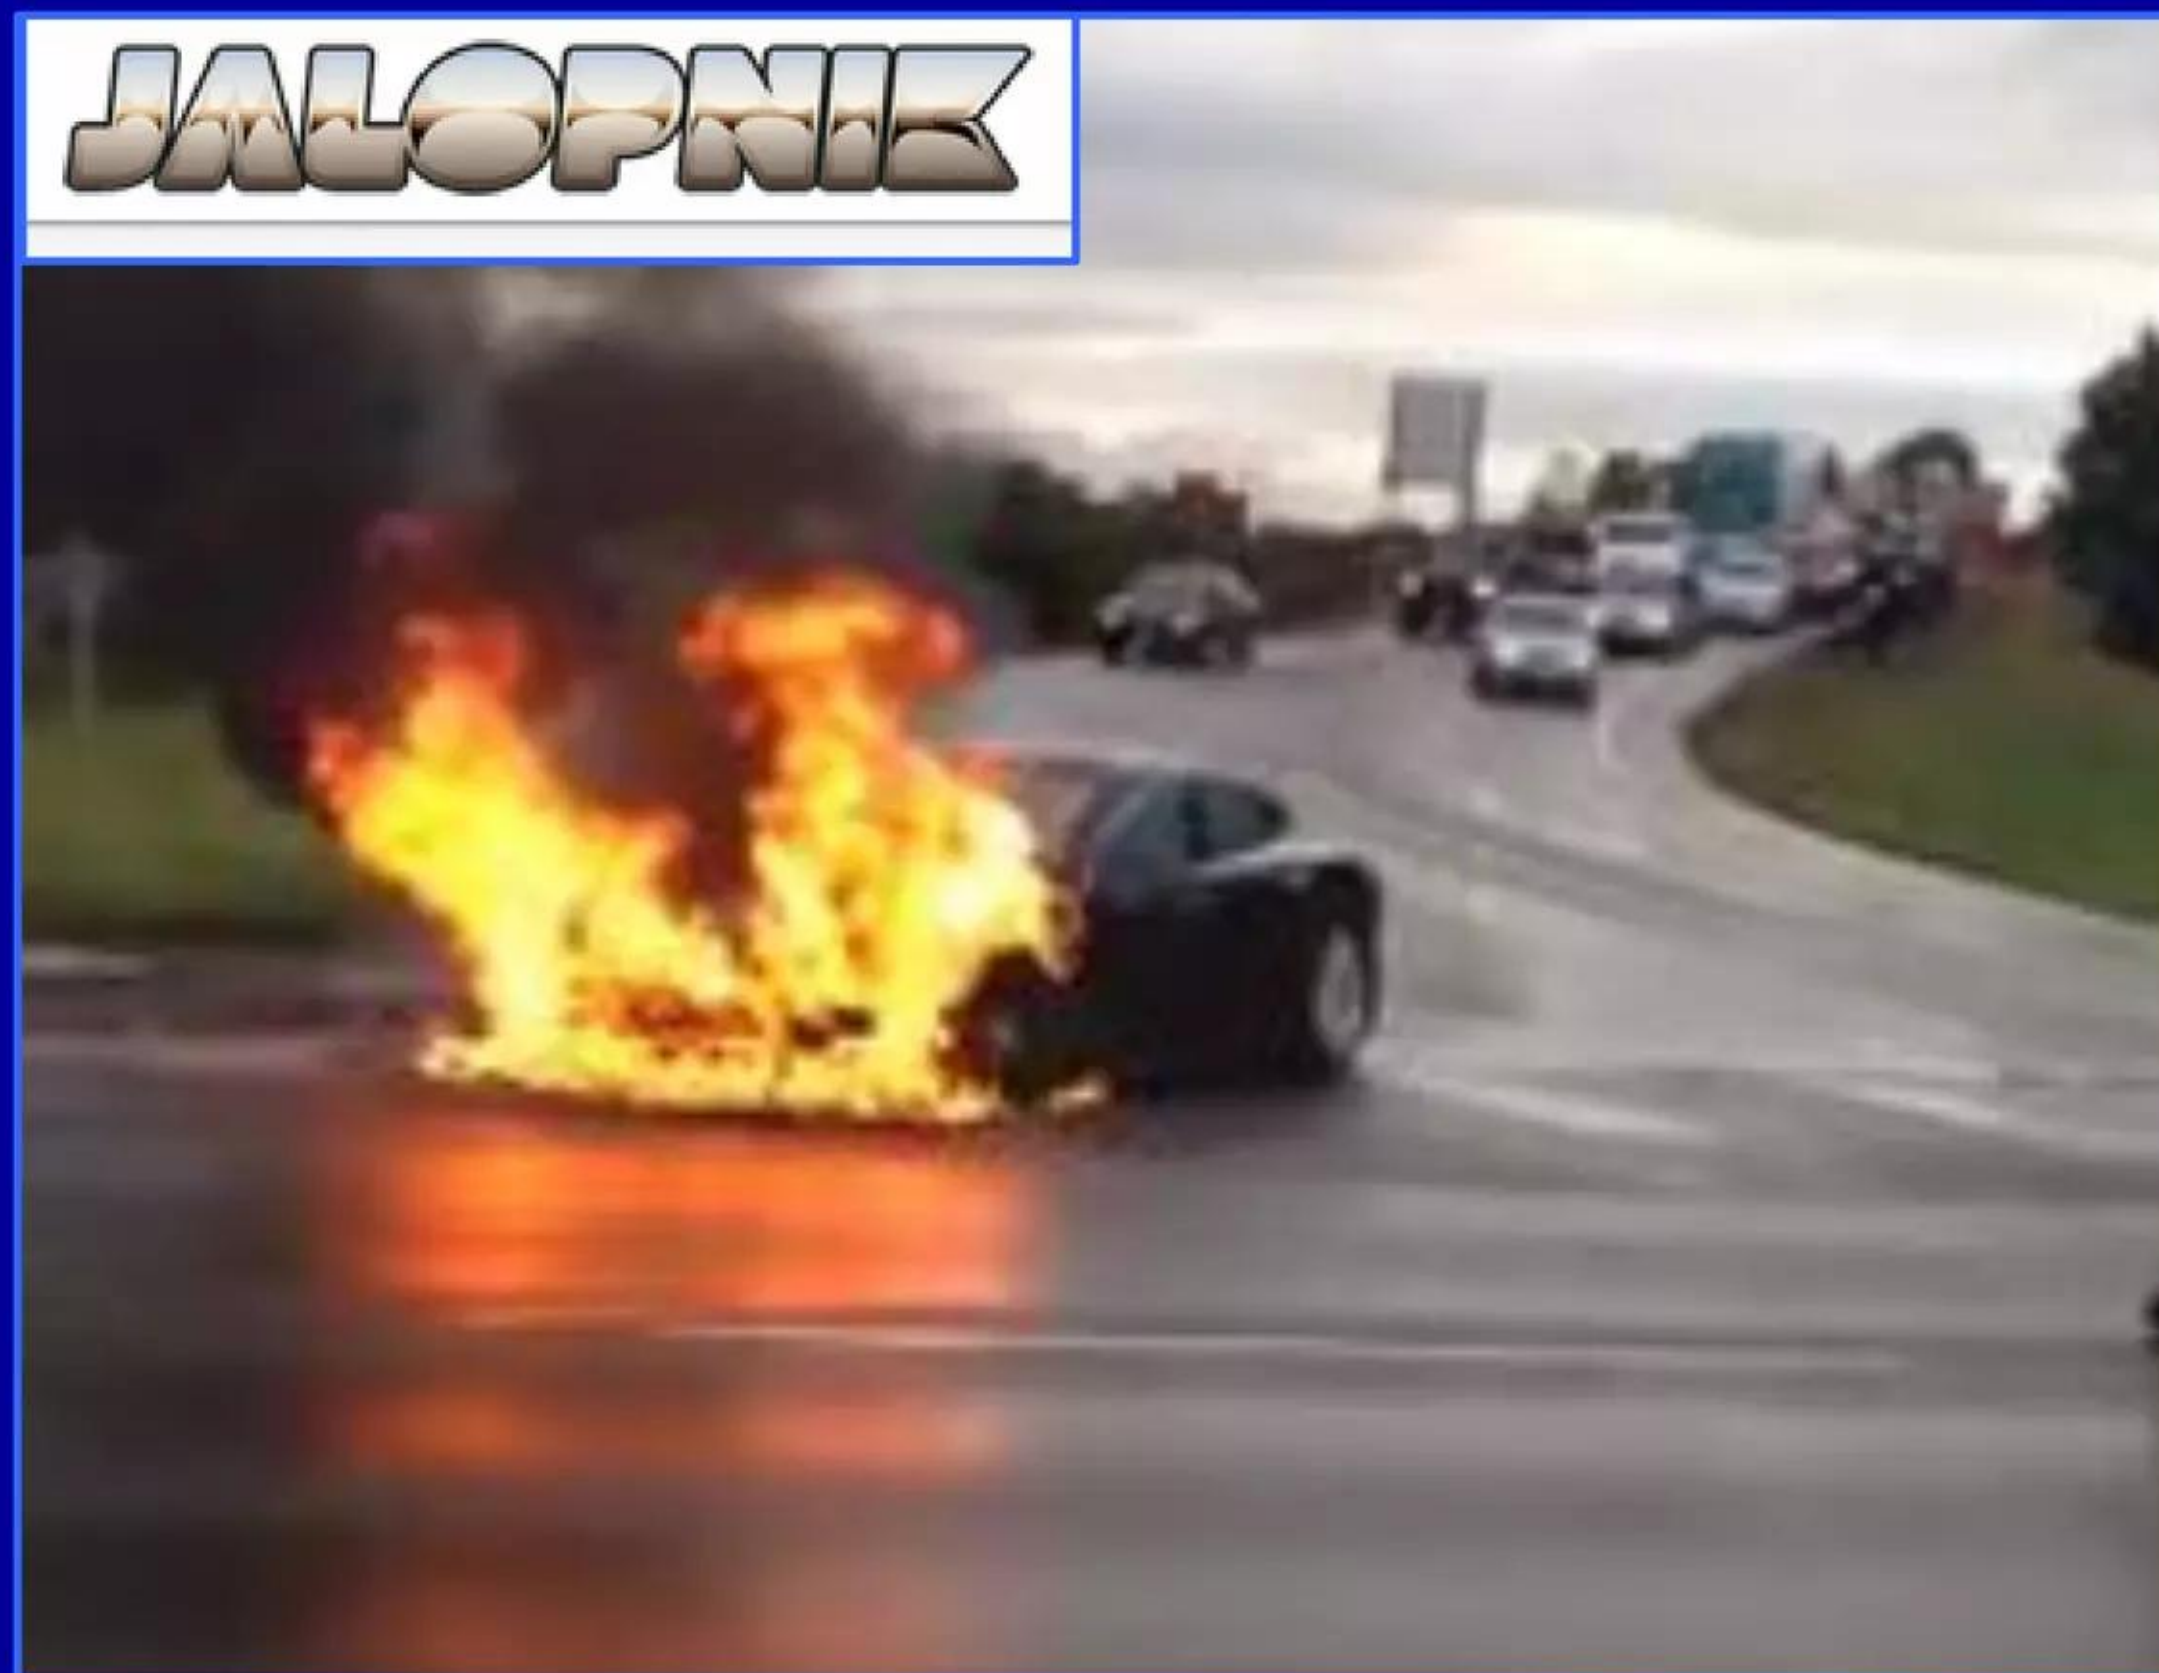
Oct. 1, 2013: Tesla Model S had battery thermal runaway
Flames are already ~6 feet high; firefighters are just arriving on scene

Image below: freeze-frame from amateur video of incident shows entire front-end of Tesla Model S completely engulfed in flames

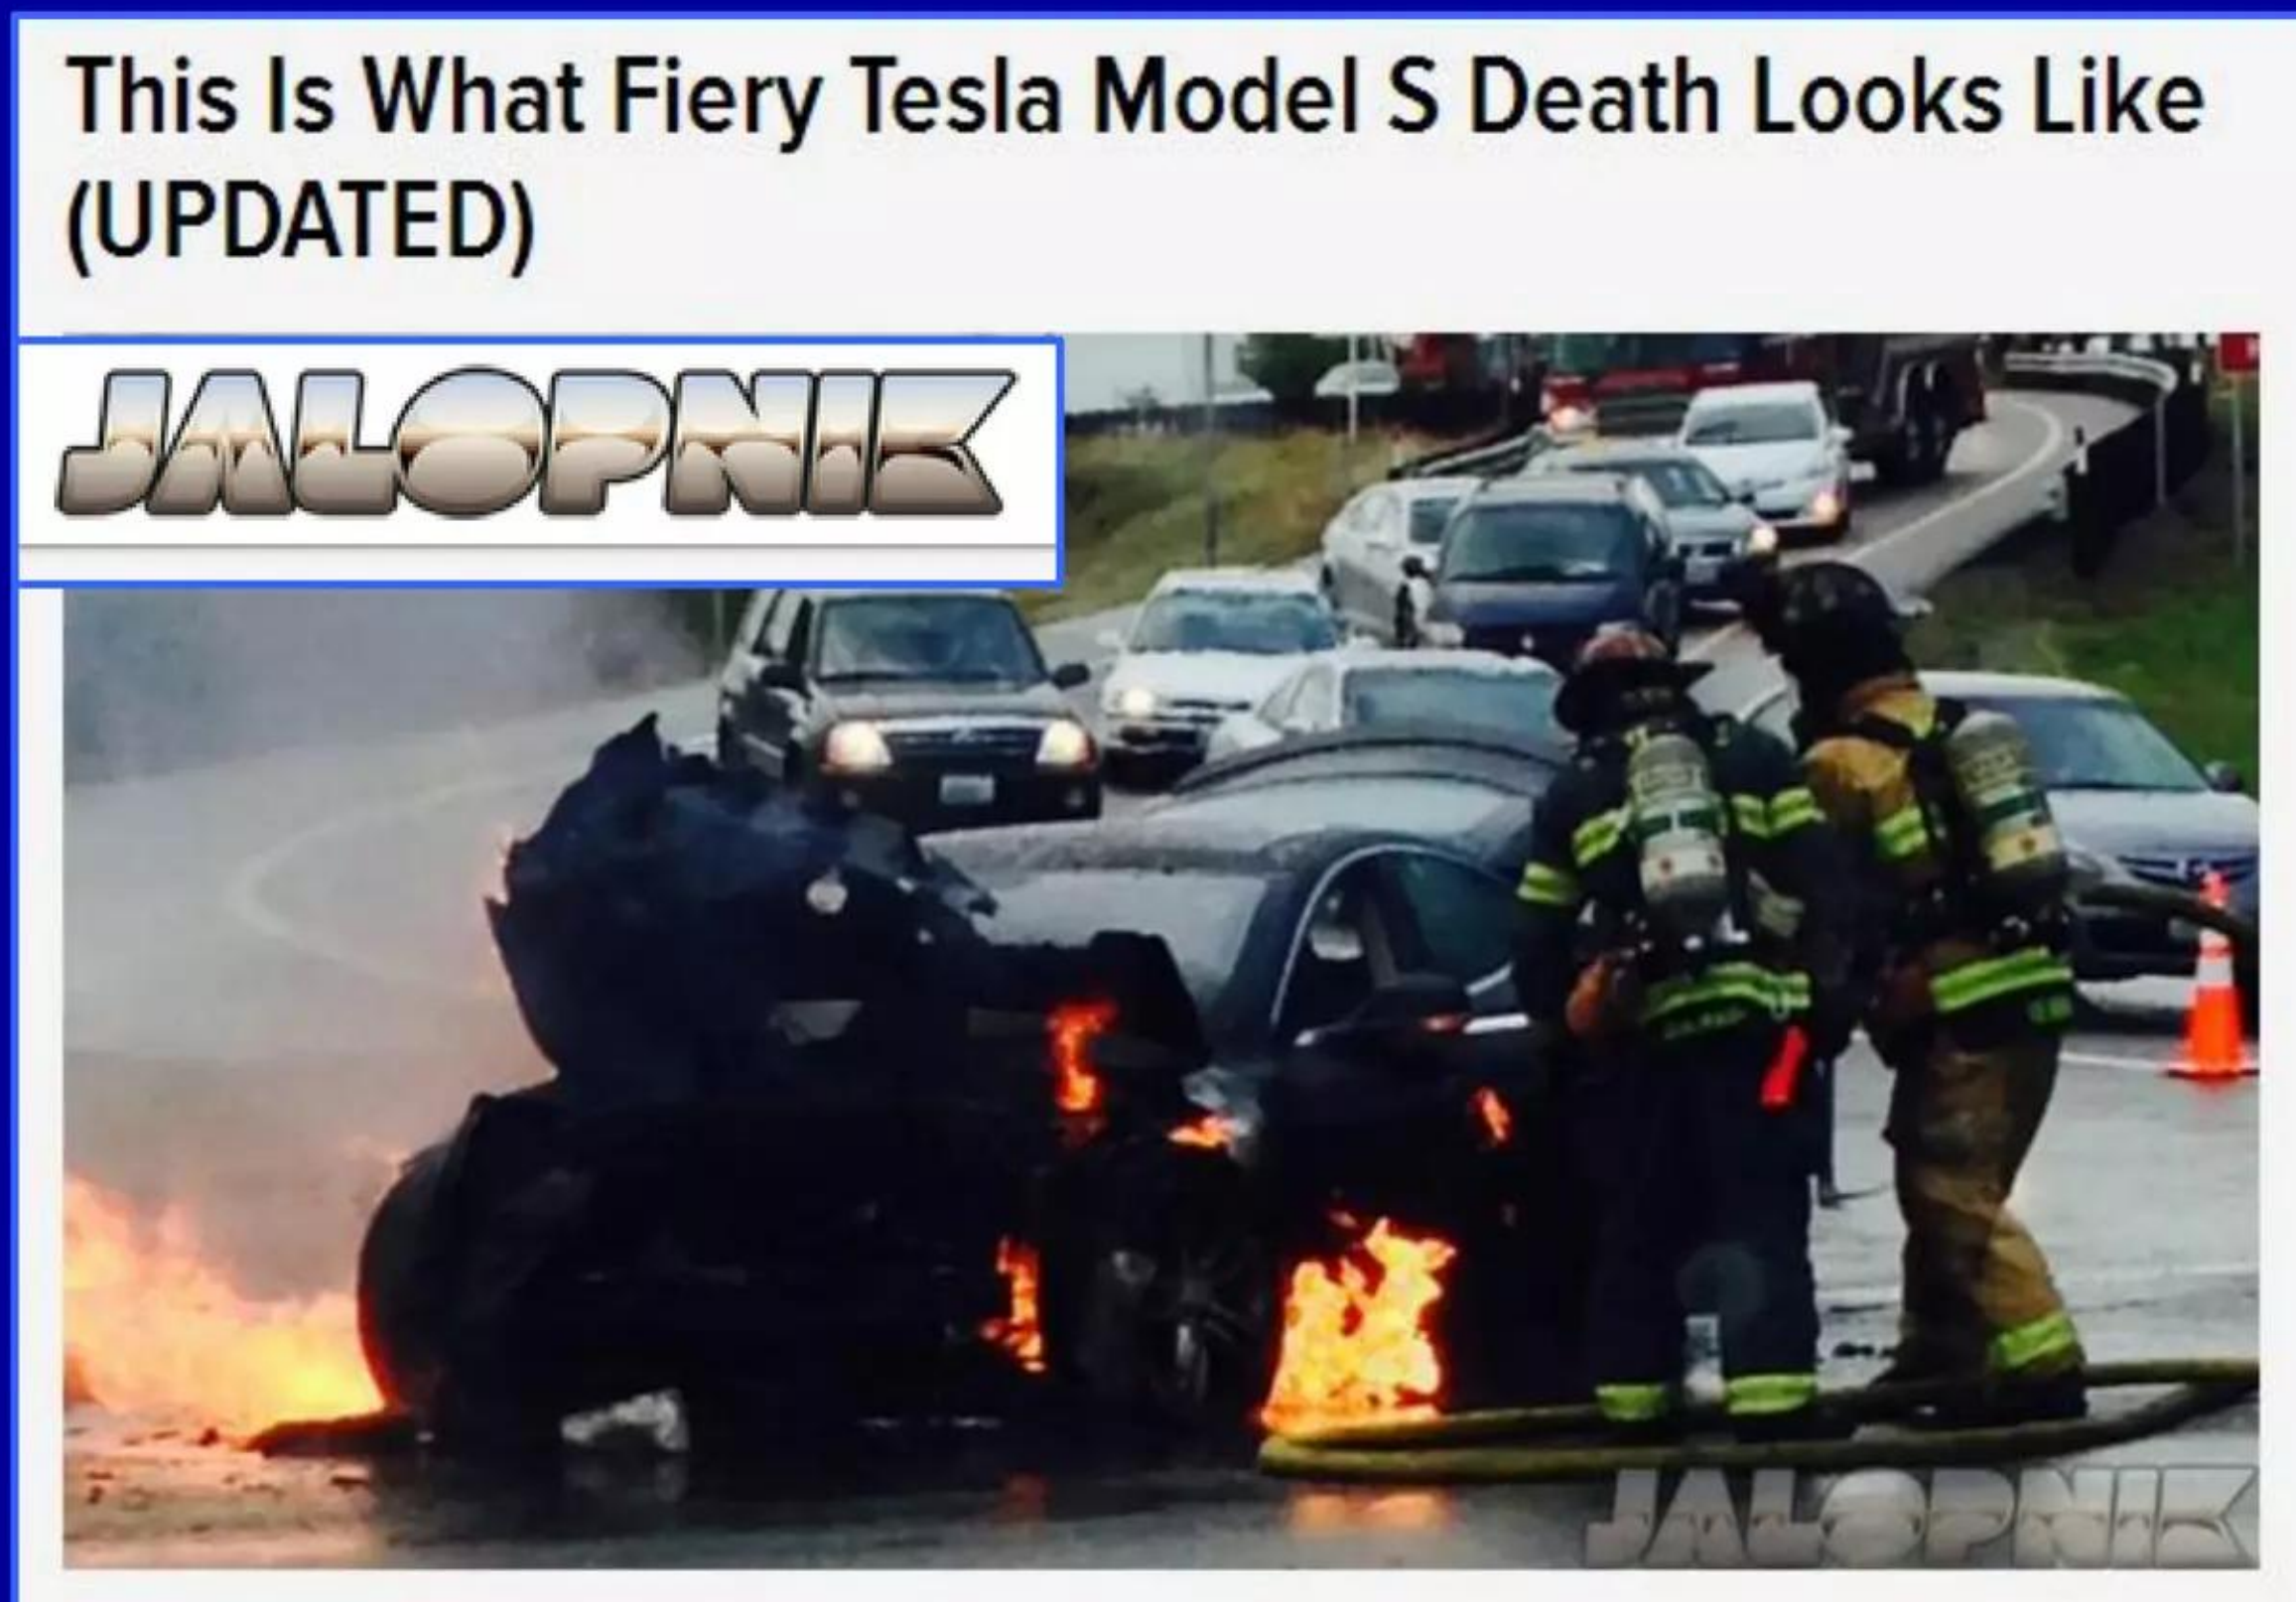
Oct. 1, 2013: Tesla Model S had battery thermal runaway
Firefighters have now cut into the hood area; still trying to control fire

E71 could not access the portion of the vehicle that was still burning. E71 had to dismantle the front end of the vehicle to gain access to the burning material. E71 found what appeared to be a battery pack in the front end of the vehicle that continued to burn. E71 had to puncture multiple holes into the pack to apply water to the burning material in the battery.
