Tesla Motors Model S battery had thermal runaway

What really caused the fiery October 1, 2013 incident?

Tesla's theory: event caused by metallic debris on road impaling battery

Theory has some issues: could it instead have been an internal field-failure?

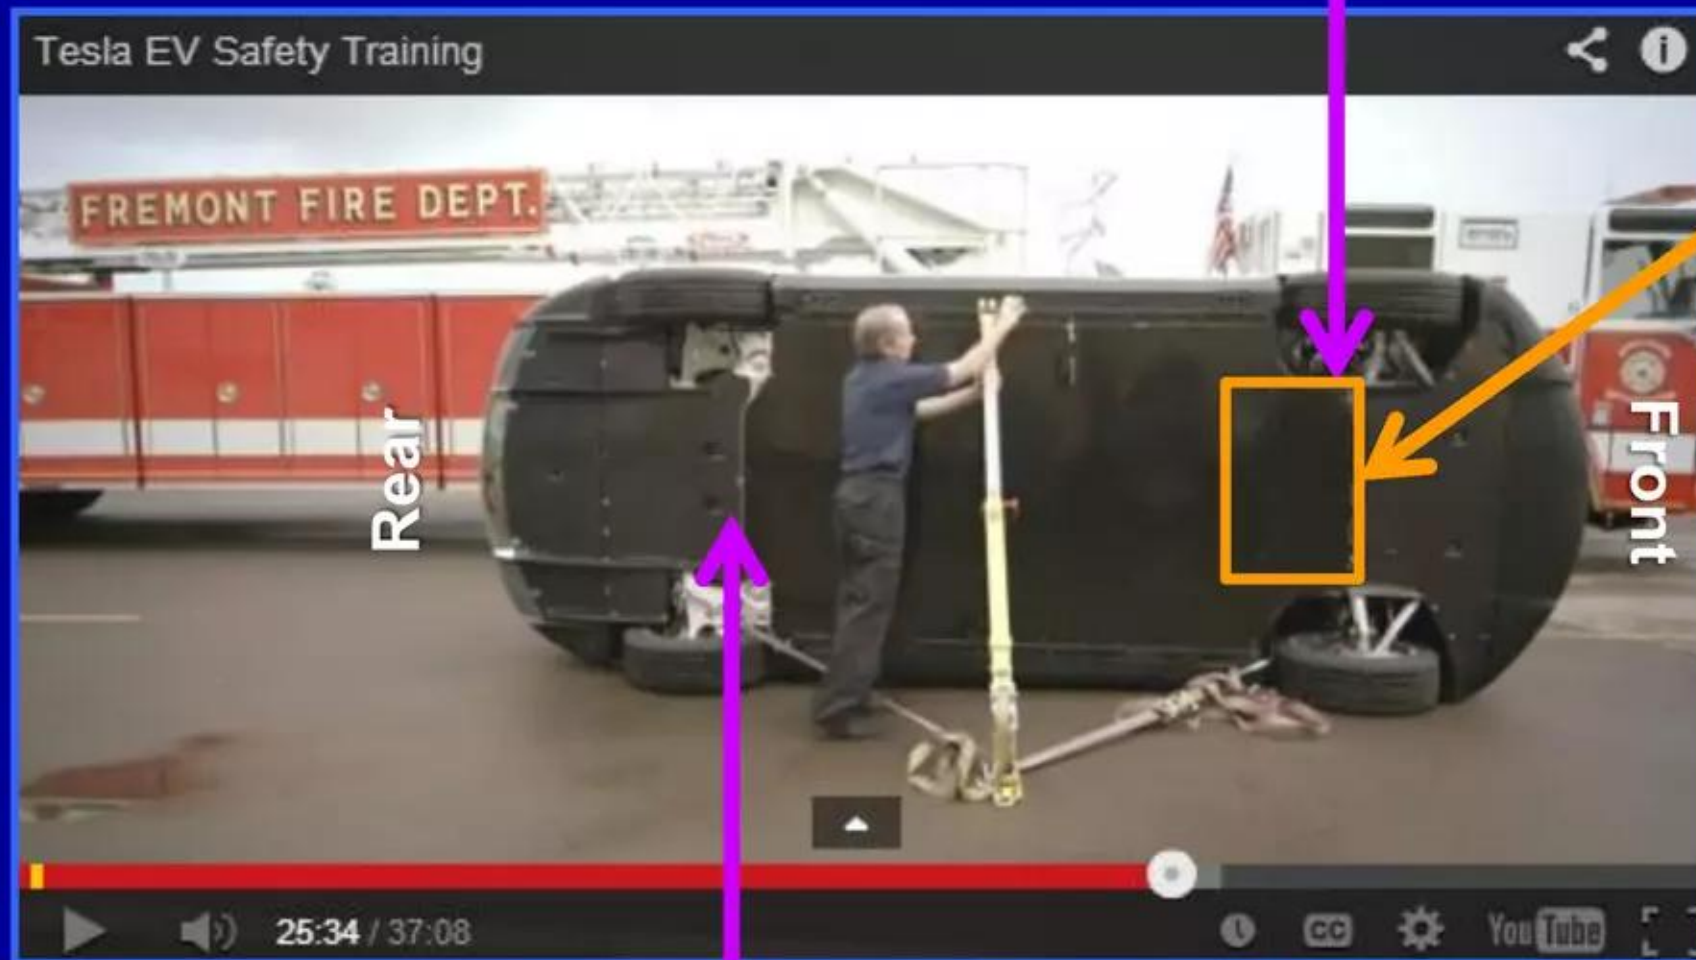
Graphical summary: metallic object's hypothesized point-of-impact

Battery pack begins right here

Tesla's theory of event posits that a "large metallic object" struck the leading front edge of battery pack, damaging the first module in the very front; **impact occurred somewhere in the area delineated by orange rectangular boxes**

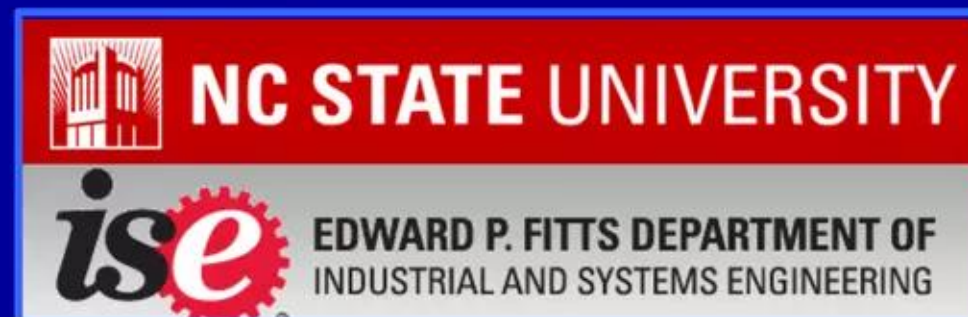
Fig. 20.6 is adapted

“Large metallic object” is punch; “armor plate” = sheet stock being punched

Nothing precisely equivalent to a rigid supporting die present in Tesla battery pack

Note: nothing precisely equivalent to a rigid supporting die is present in Tesla battery pack. So as “large metallic object” (= punch) is piercing the protective “armor plate” (= “sheet stock” in Figure to right) it will experience elastic bending ‘give’ prior to punch-through because Tesla’s “armor plate” is probably ductile, flexible metal. In practical terms, this means that the amount of real-world force that would be required to punch a ~3” diameter hole through the Tesla battery pack’s “armor plate” is likely to be larger than what we calculate with pure shear-force formulas used herein. **Our estimated force thus probably conservative; perhaps lower by as much as ~20%**

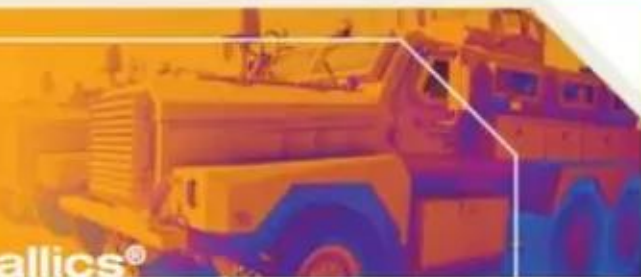
Let's examine ATI Defense commercial version of steel used in military armor

ATI 500-MIL® High Hard Specialty Steel Armor

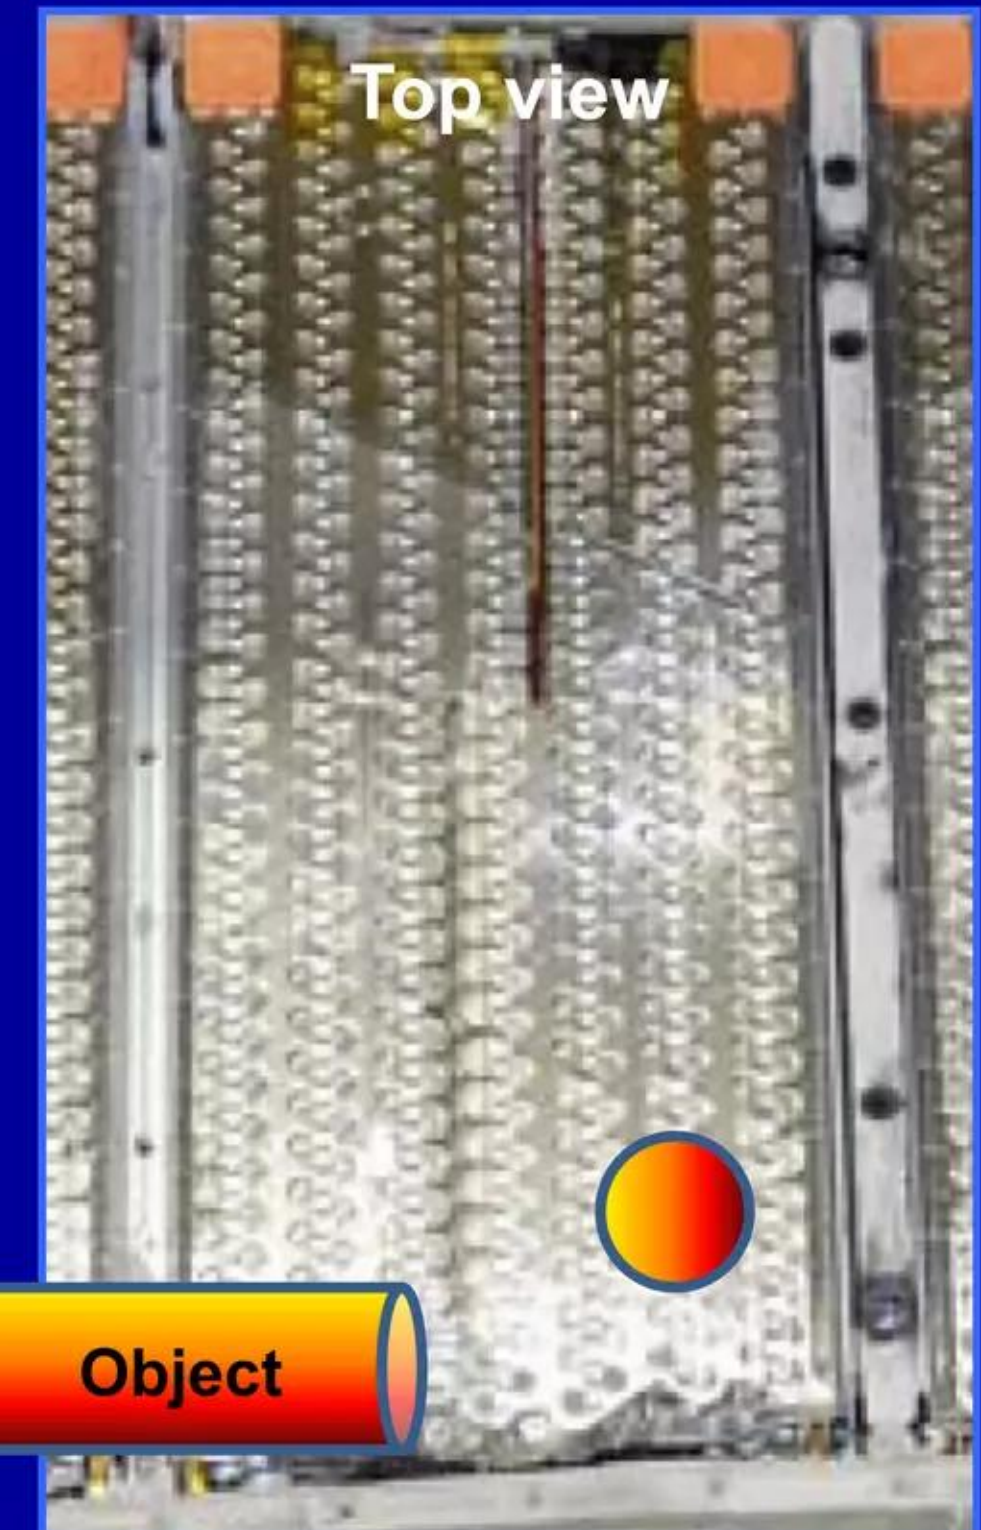
Batteries oriented vertically in Tesla module

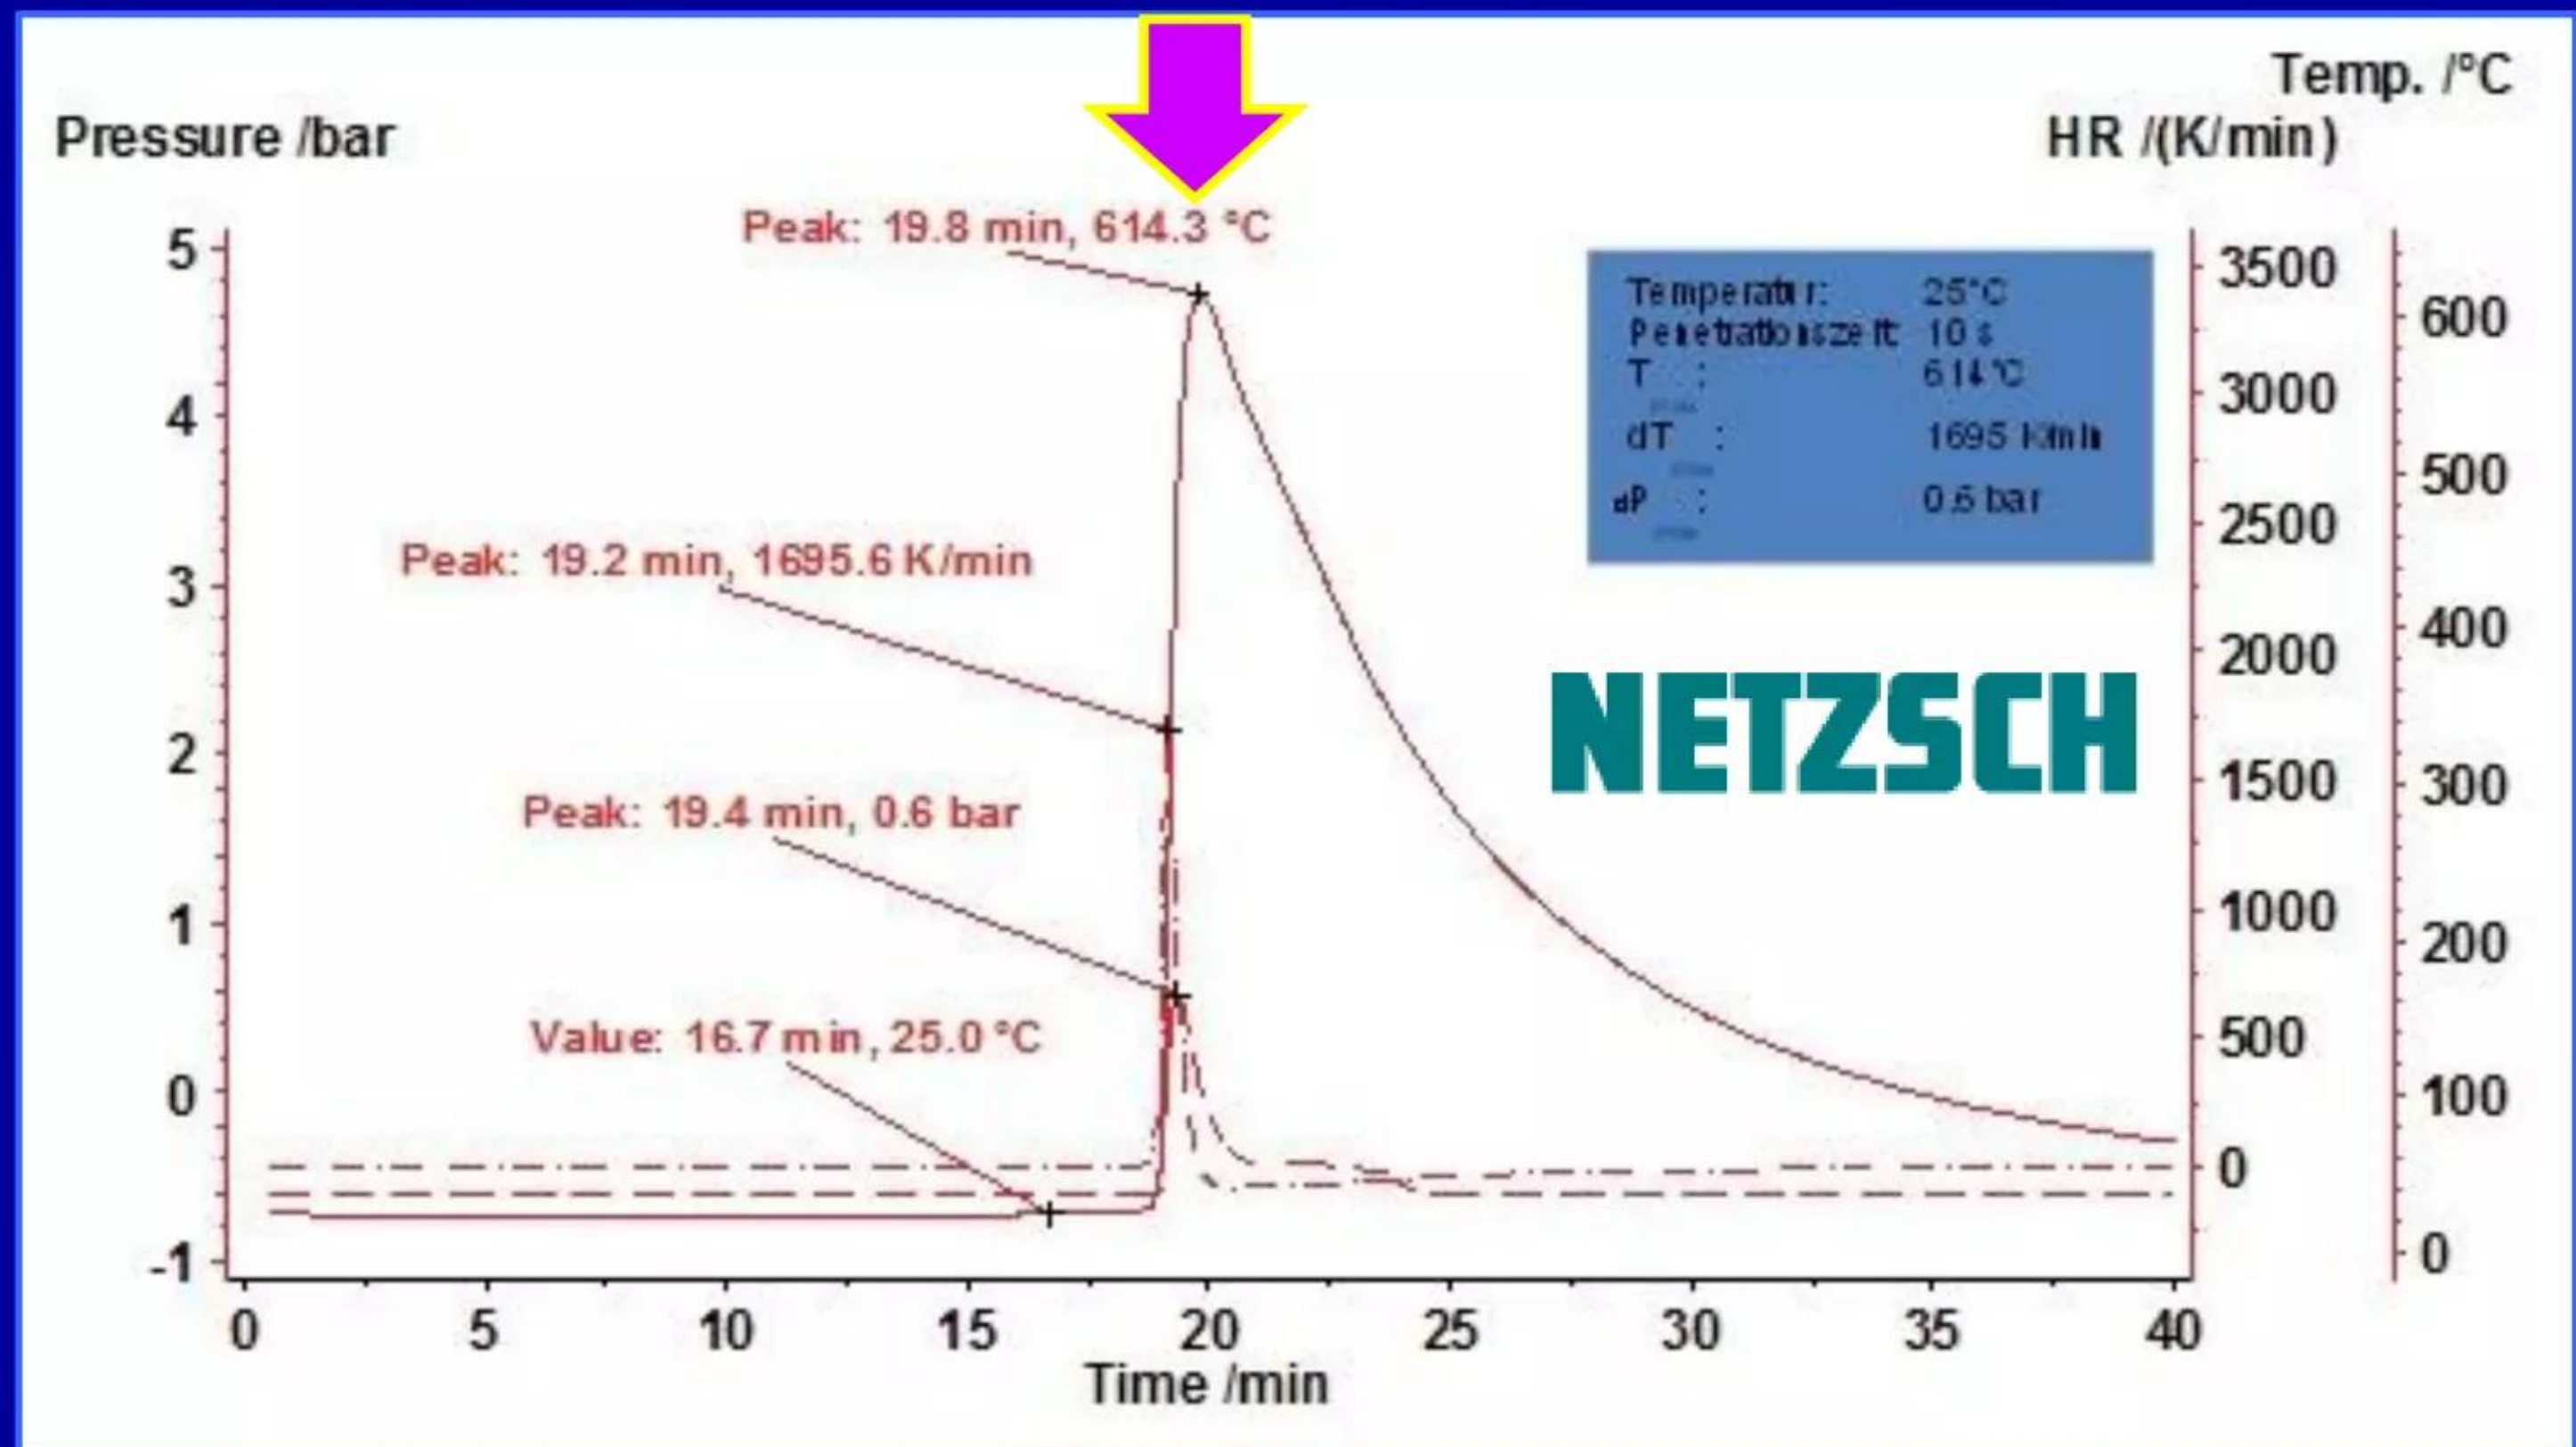
Quoting: "Figure 3 shows the set of measurement results for a charged 18650 cell at room temperature. The cell was kept at a constant temperature within the calorimeter over a period of 18 minutes. The metal perforator penetrated the battery cell for a period of ten seconds and was then re-withdrawn from the battery. The electrical short circuit caused the temperature during the reaction to reach a maximum value of 614°C at a heating rate of roughly $1,700\text{ K/min}$."

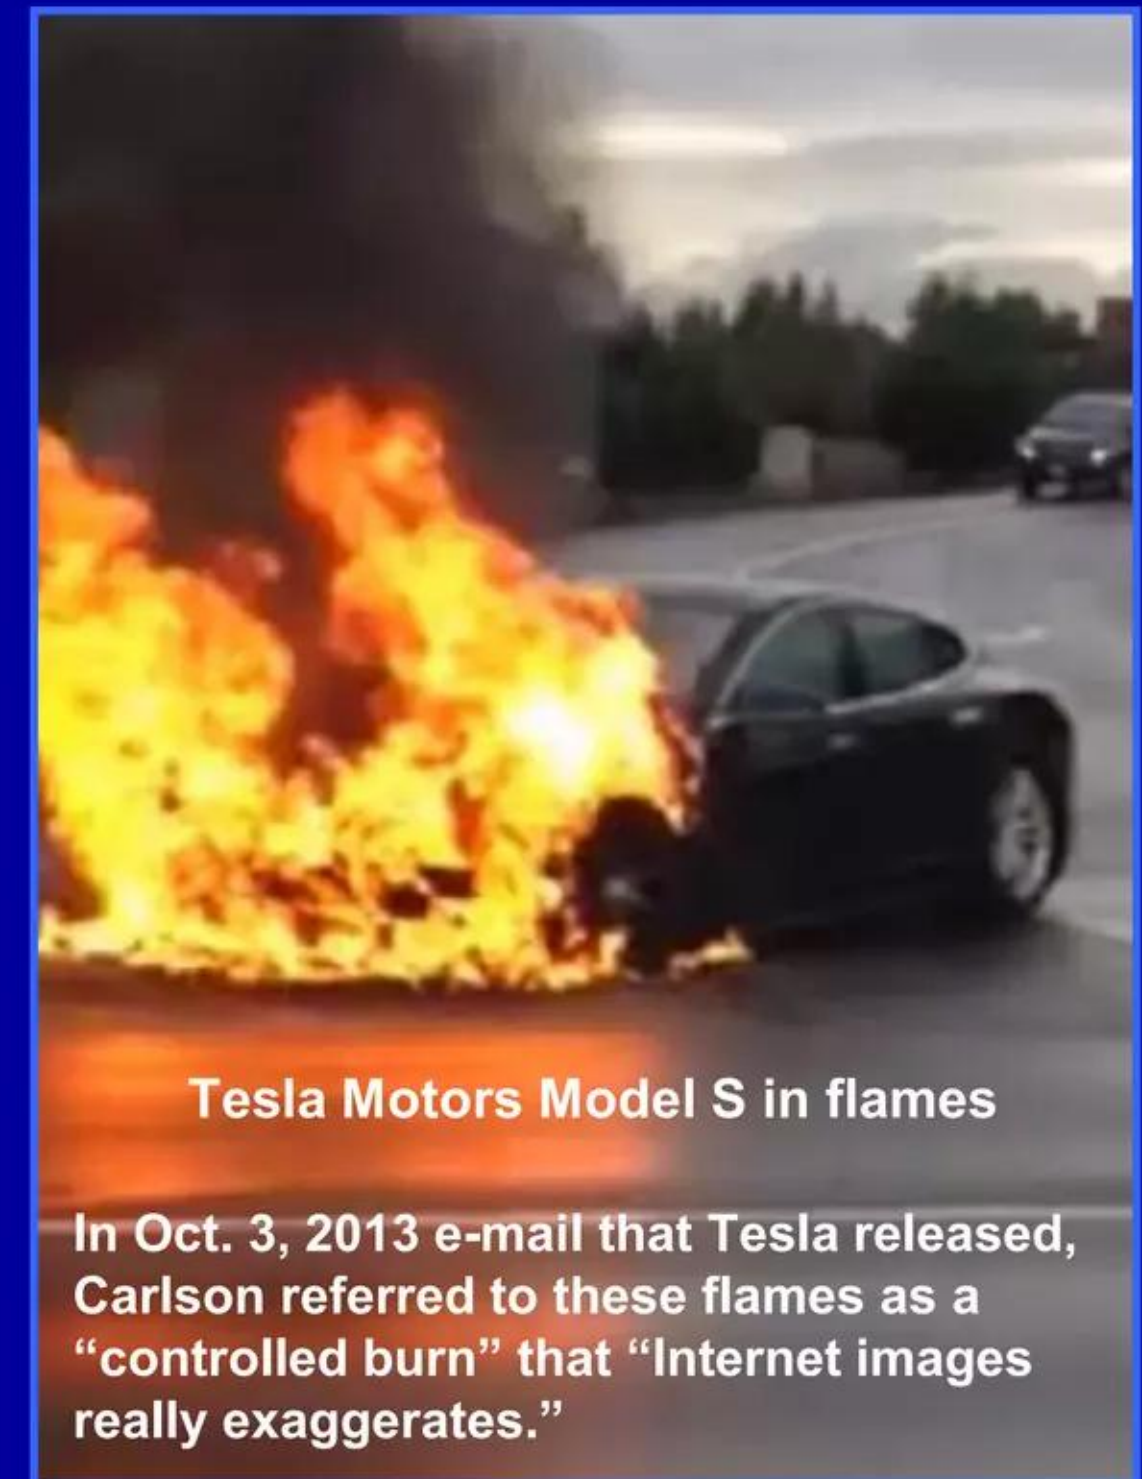
October 1, 2013 - Kent, WA USA
Scene just as firefighters arrived

Lattice comment:
If this mini-inferno is truly "controlled" then we are astounded.

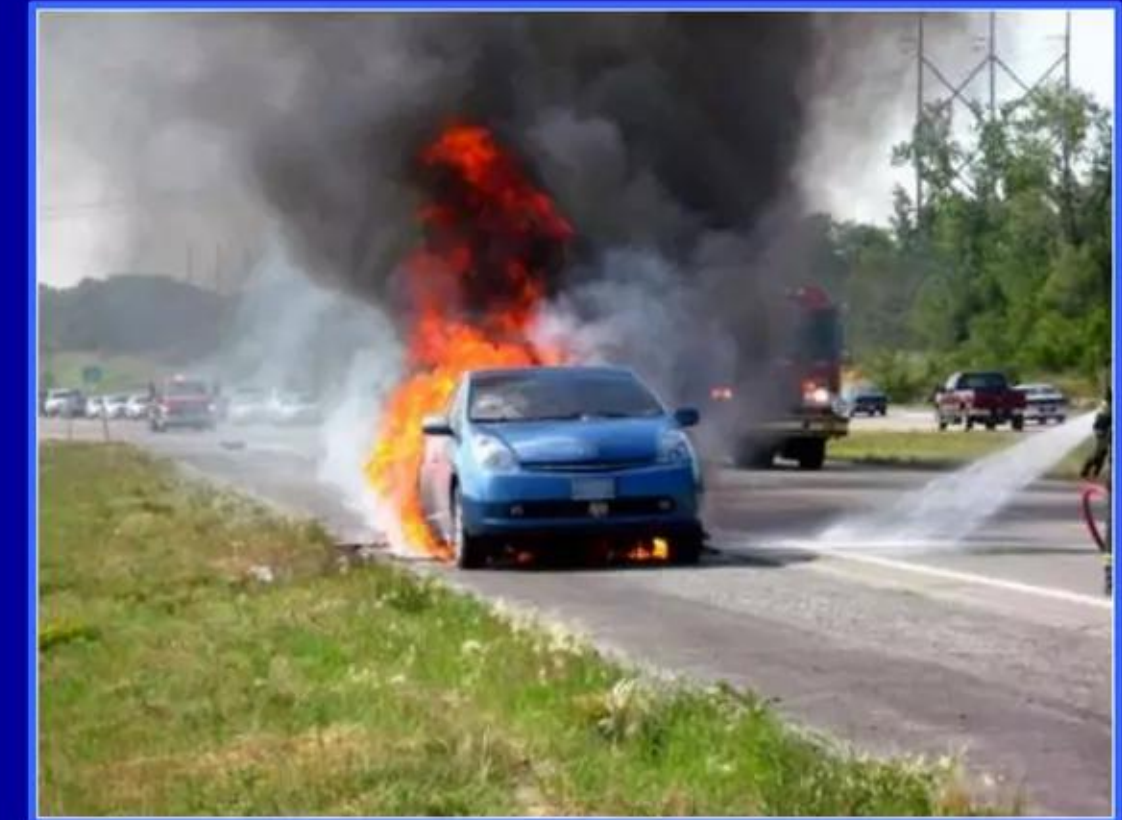
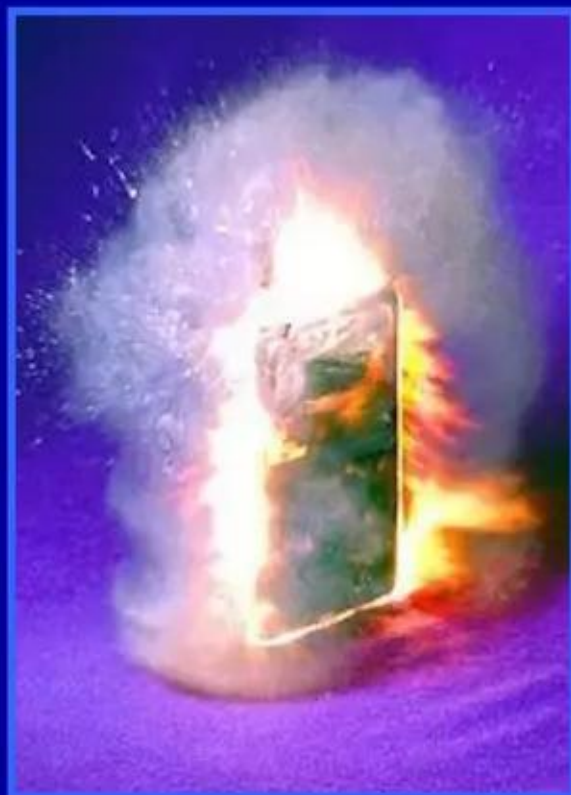
- Temps: $\sim 300^{\circ}\text{C}$ up to 600°C (Lattice’s criteria)
- Reasonably well understood failure events
- Triggered by substantial over-charging or excessively deep discharges of Li batteries
- Triggered by external mechanical damage to battery cells, e.g., crushing, punctures; **growth of internal Li dendrites can mechanically pierce plastic separators**

Field-failure thermal runaways also typically include electric arc shorting:

- Temps: $> 600^{\circ}\text{C}$ - can go up to thousands of $^{\circ}\text{C}$ with electric arcs
- Much rarer and comparatively poorly understood
- Many believe triggered and/or accompanied by electrical arc discharges (internal shorts); **what causes initial micro-arcs?**
- Much higher peak temperatures vs. garden variety events
- Lattice suggests: **super-hot low energy nuclear reactions (LENRs) could well be initial triggers for some % of them**
